## PLUGIN 510 - 803 - 965:NEW TRASDATA

## ECU CONNECTOR

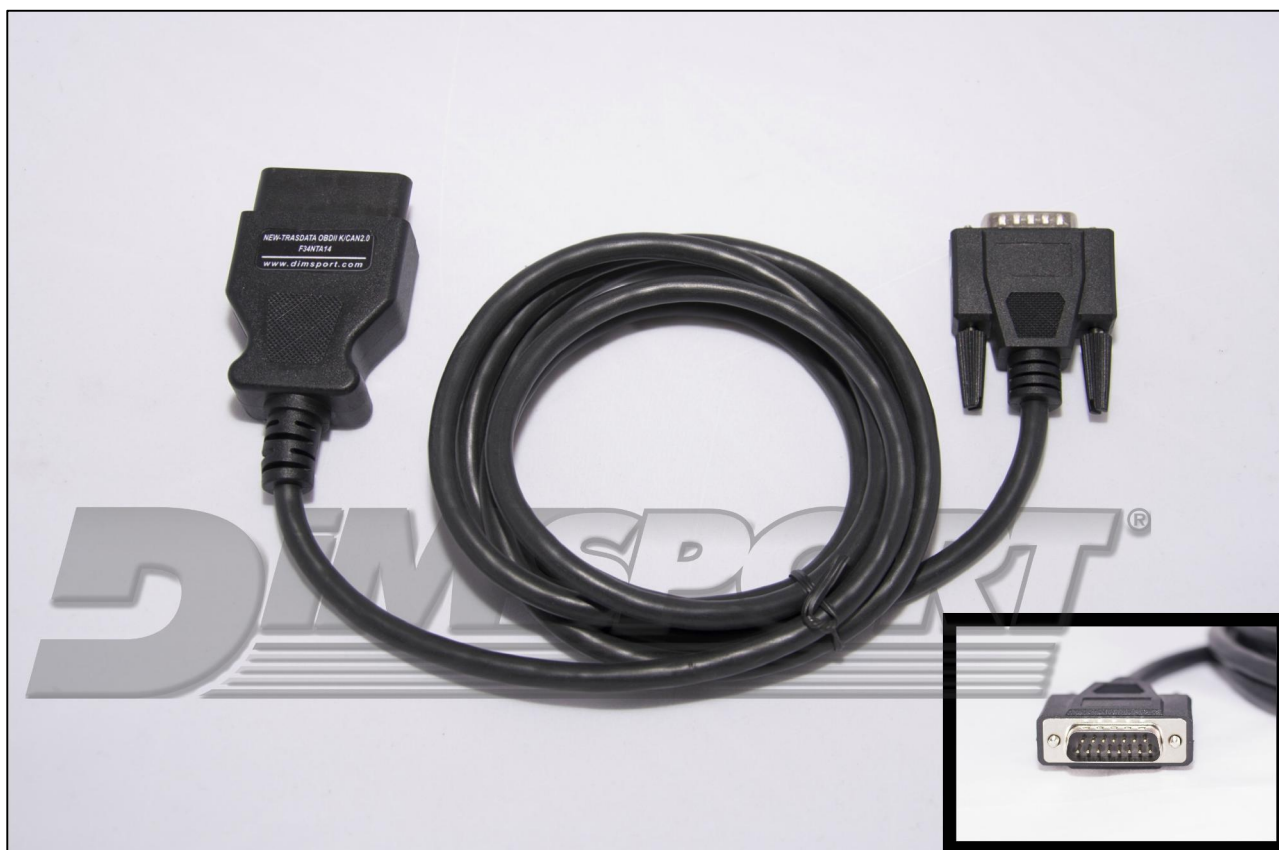
Required cable for ObdData operation: F34NTA14

1. connect New Trasdata tool to the pc via USB
2. connect F34NTA14 cable to the New Trasdata DB25 port
3. connect the F34NTA14 cable to the vehicle OBDII port
4. run the sw to manage the New Trasdata tool
5. select the correct connection mode for the vehicle
6. click on ObdData button
7. wait until the end of the ObdData procedure

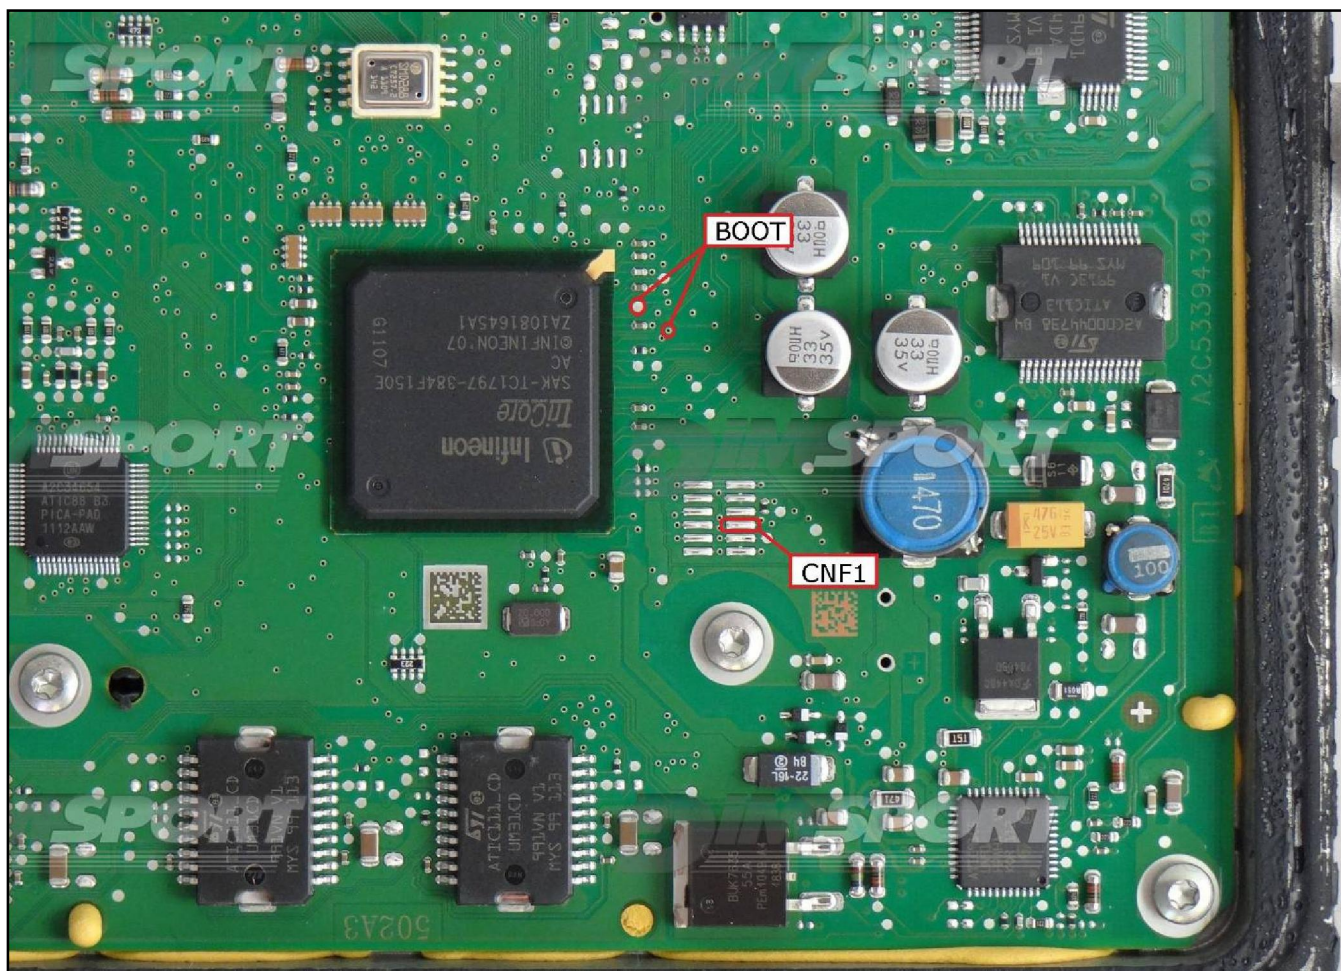
## 2. DIRECT BOOT&CNF1 CONNECTION

Connect the BLUE and GREY wires of the cable F32GN037C as described here below :
